# Charting Solutions in a Resilient City 2.0, Tidewater, Virginia

Portsmouth, NH  
May 7-9, 2023

# TEST PROTOCOL 1.1 PURPOSE & PARTNERS

# OUR WORK: 722 FILER STREET

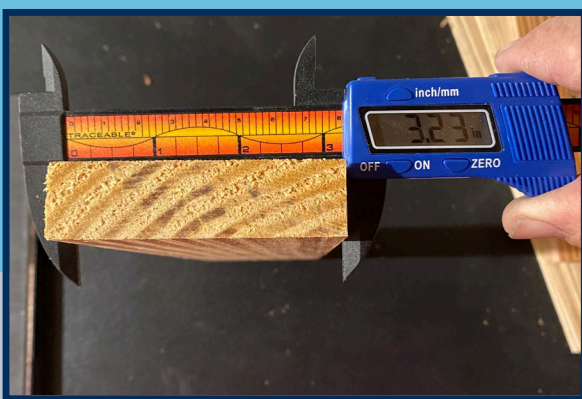
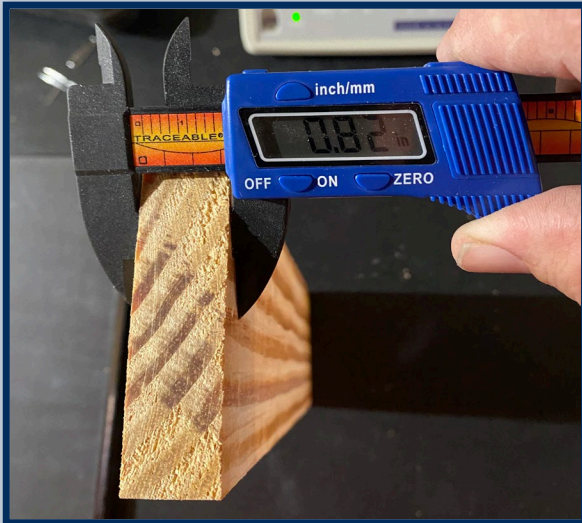
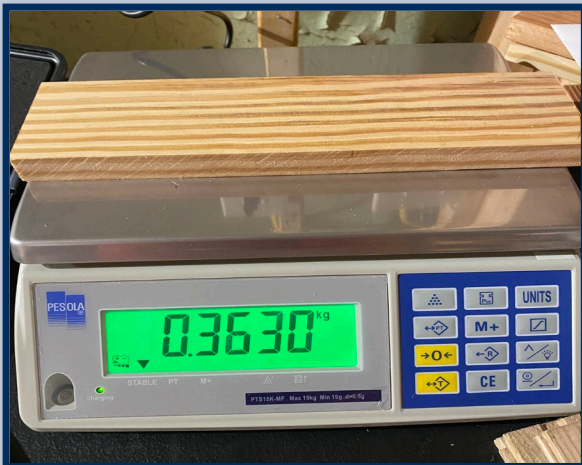
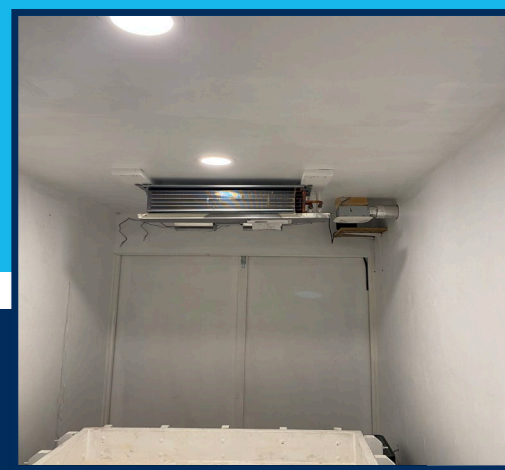
# TEST PROTOCOL 1.1 DESIGN

## How? The Flood Chamber

- Can be flooded to simulate flood event
- Drained after set period of time to replicate a drying period

## Data Collected

Changes occurring in wood samples:

- Width
- Thickness
- Weight
- Moisture Content

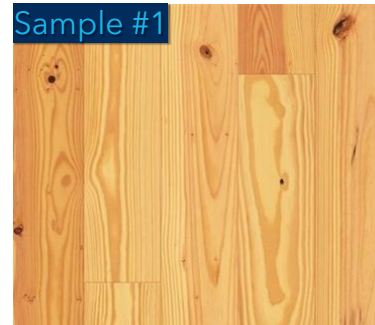
Sample #1

Flooring samples representative of common flooring materials in Tidewater, VA

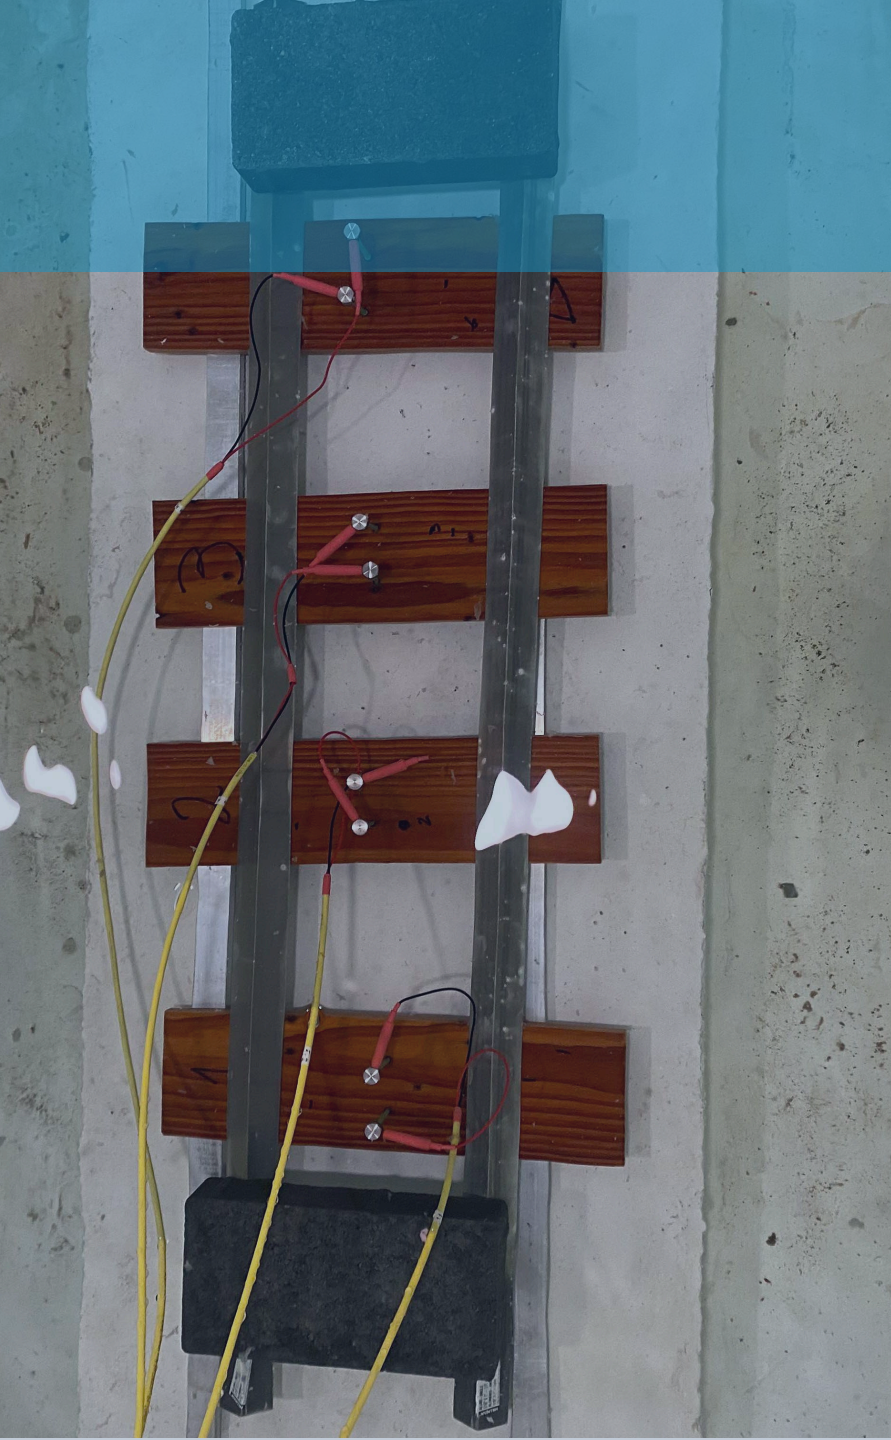
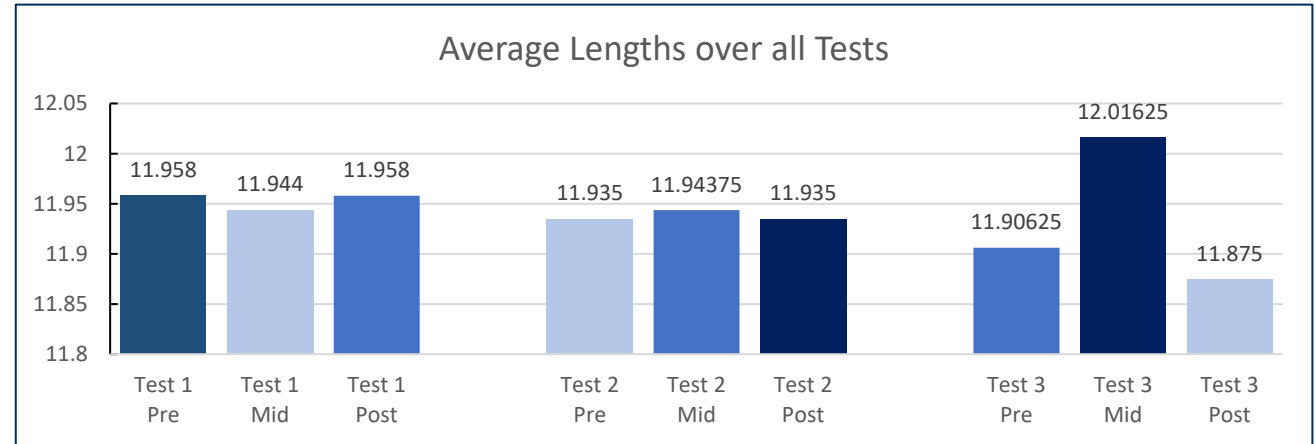
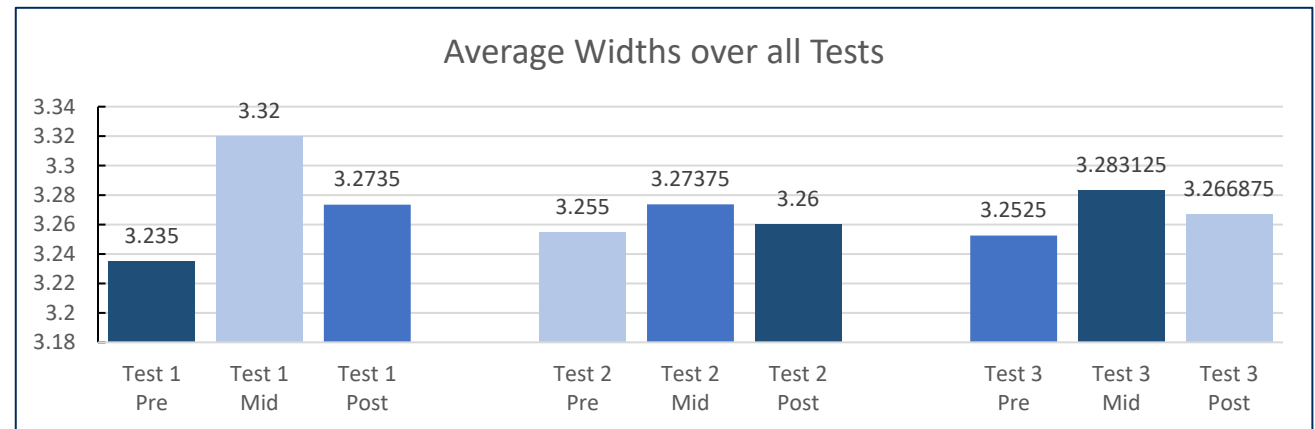
# TEST PROTOCOL 1.1 DATA

- Modern growth had little dimensional stability
- Wood commonly found in floors in pre-1970 structures generally outperformed modern low-to-moderate wood used in modern flooring

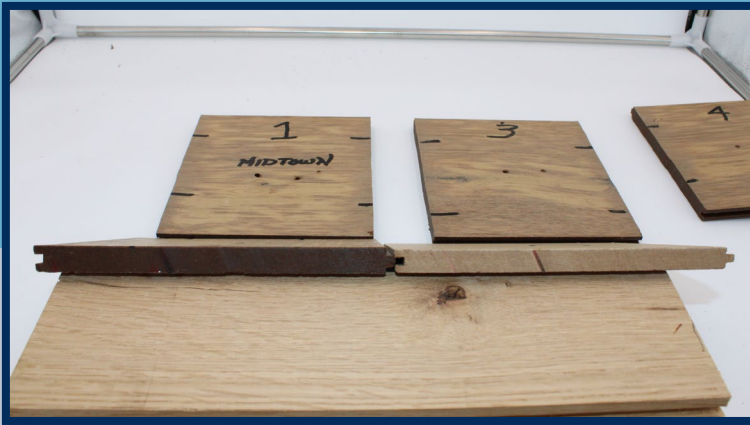
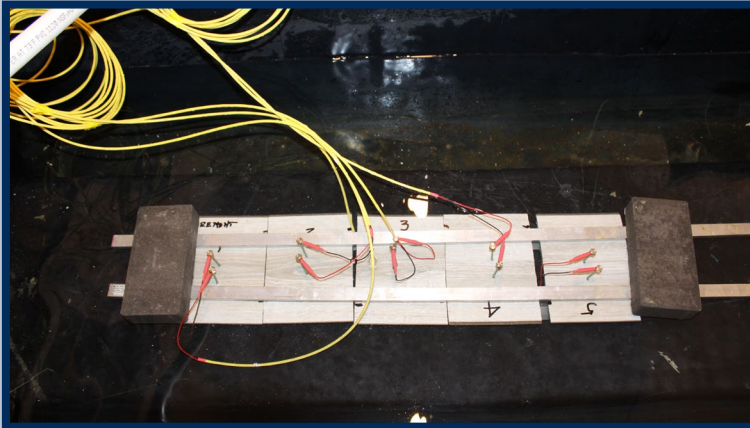
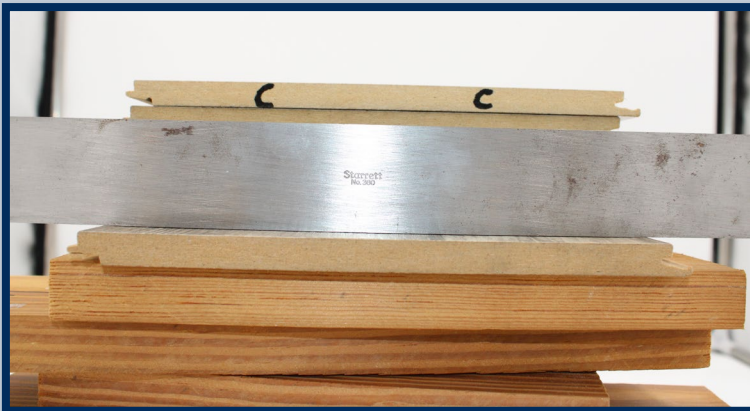
# TEST PROTOCOL 1.2 DESIGN

## How? The Flood Chamber

### Same conditions used for Protocol 1.1

- Made to replicate a flood event
- Drained after set period of time to replicate a drying period

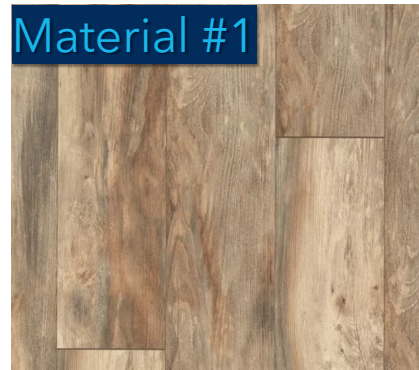
Material #1

- Pergo Wet-Protect Brentwood Pine Wood Plank Laminate Flooring
- Freemont Eco Resilient Flooring
- Midtown Light Oak Wire-Brushed Engineered Hardwood

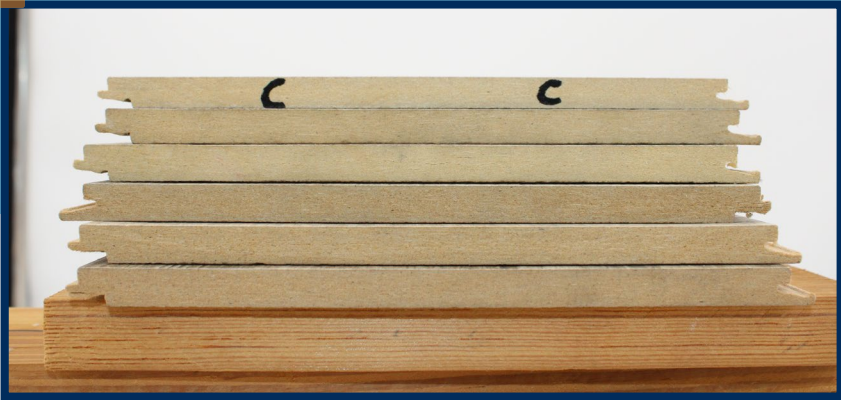
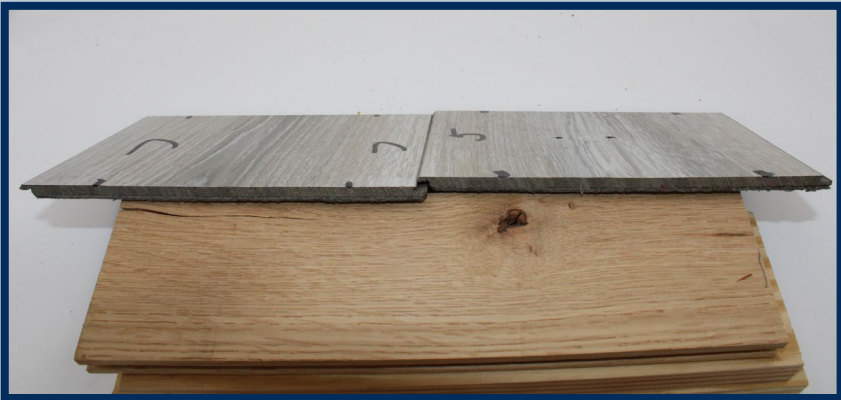
# TEST PROTOCOL 1.2 DATA

Comparison of Average Length from all Rounds

Comparison of Average Width from all Rounds

- All engineered flooring tested exhibited dimensional instability: Samples cupped and distorted in thickness and width
- Engineered products with no wood in their composition were the most resilient of the group  
While moderately resistant to moisture the engineer products can not be repaired post flooding
- While moderately resistant to moisture, the engineered products cannot be repaired post flood event

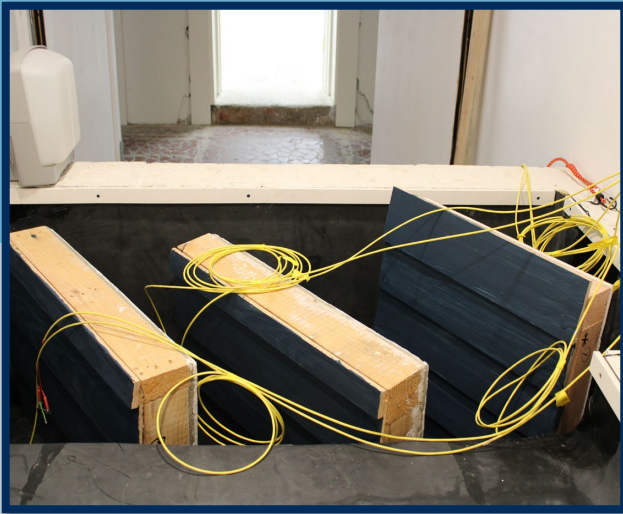
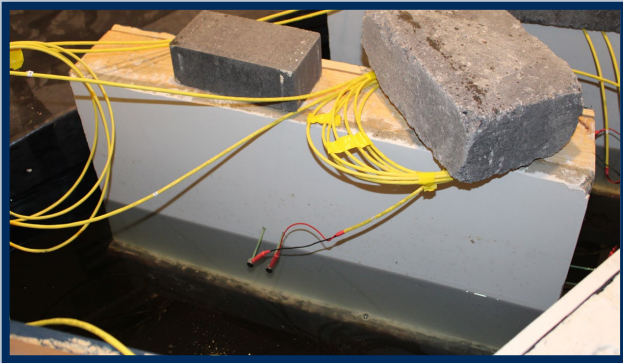
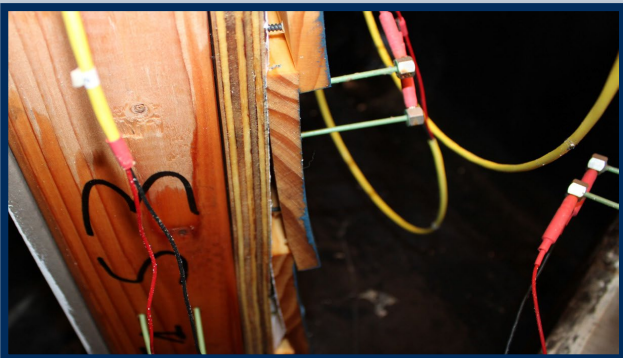
# TEST PROTOCOL 2.1 DESIGN

## How? The Flood Chamber

- Made to replicate a flood event
- Can be flooded to simulate flood event
- Drained after set period of time to replicate a drying period

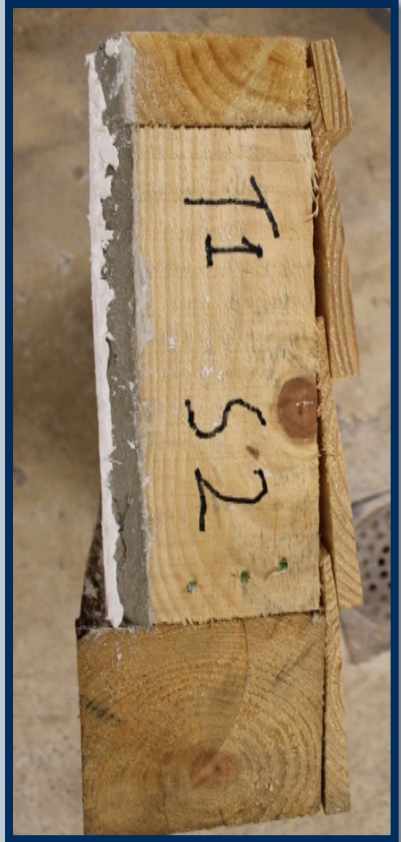
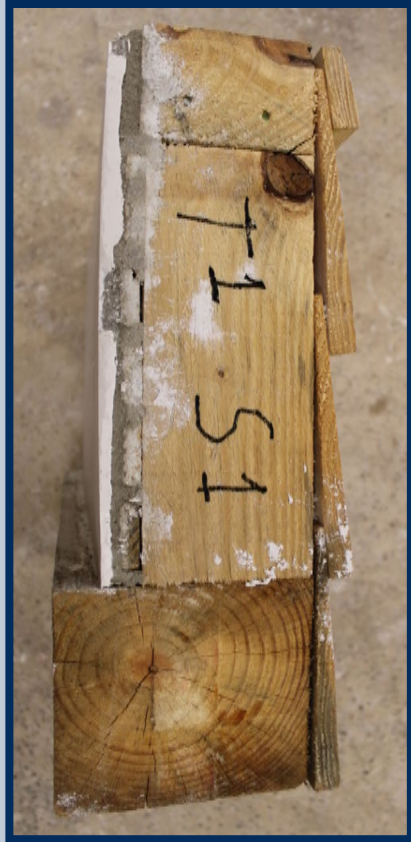
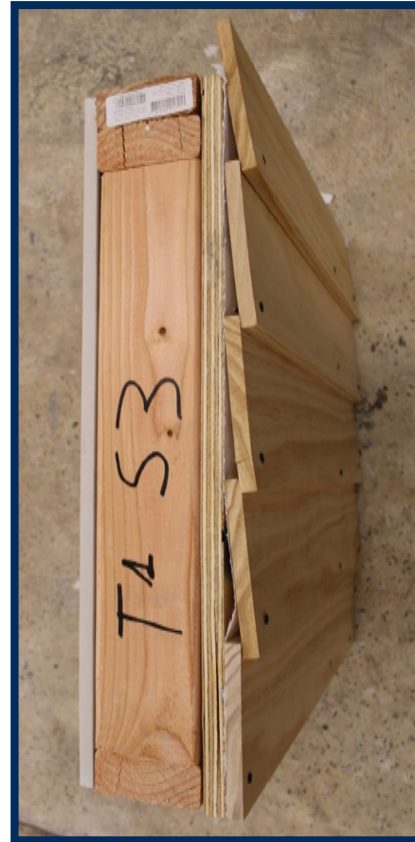
# TEST PROTOCOL 2.1 DESIGN

Replicated assemblies representative of common assemblies in Tidewater, VA

- Plaster on Wood Lath with taper sawn Southern Yellow Pine Siding
- Plaster on Wire Lath with taper sawn Southern Yellow Pine Siding
- Modern Drywall with taper sawn Southern Yellow Pine Siding

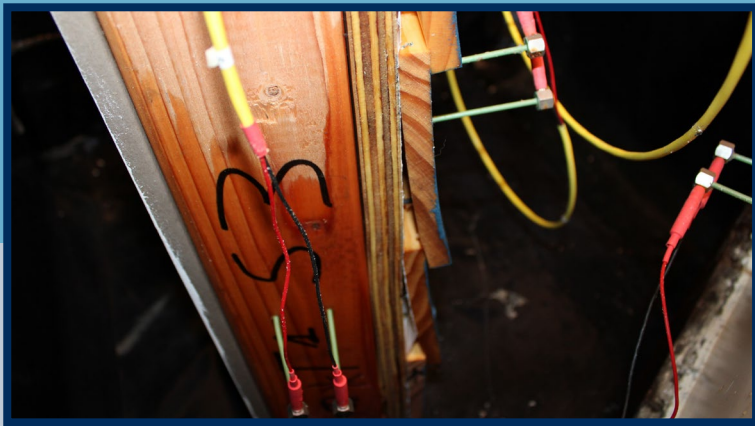
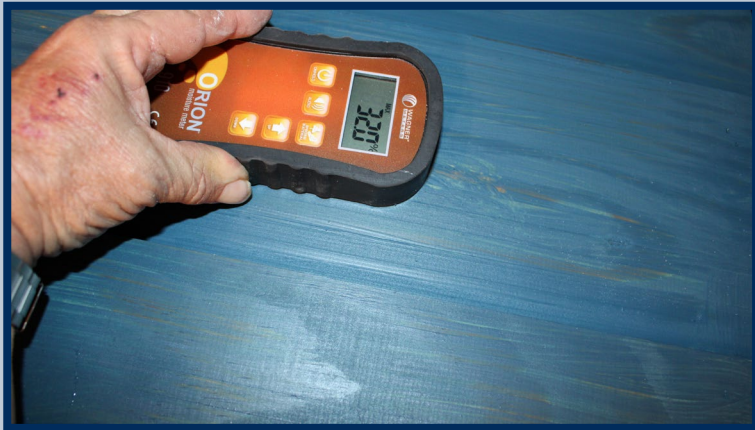
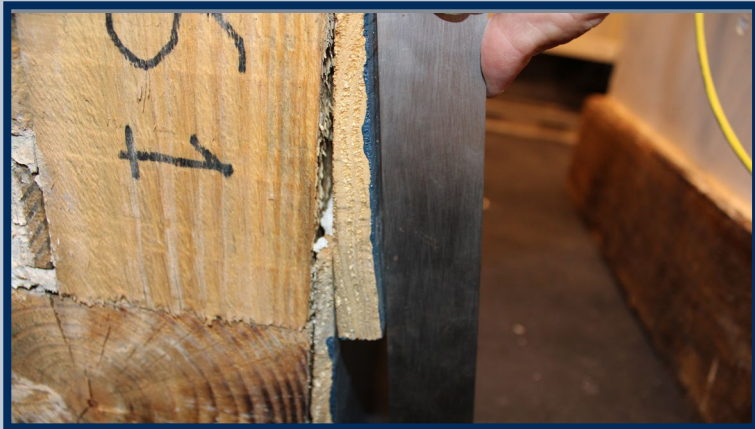
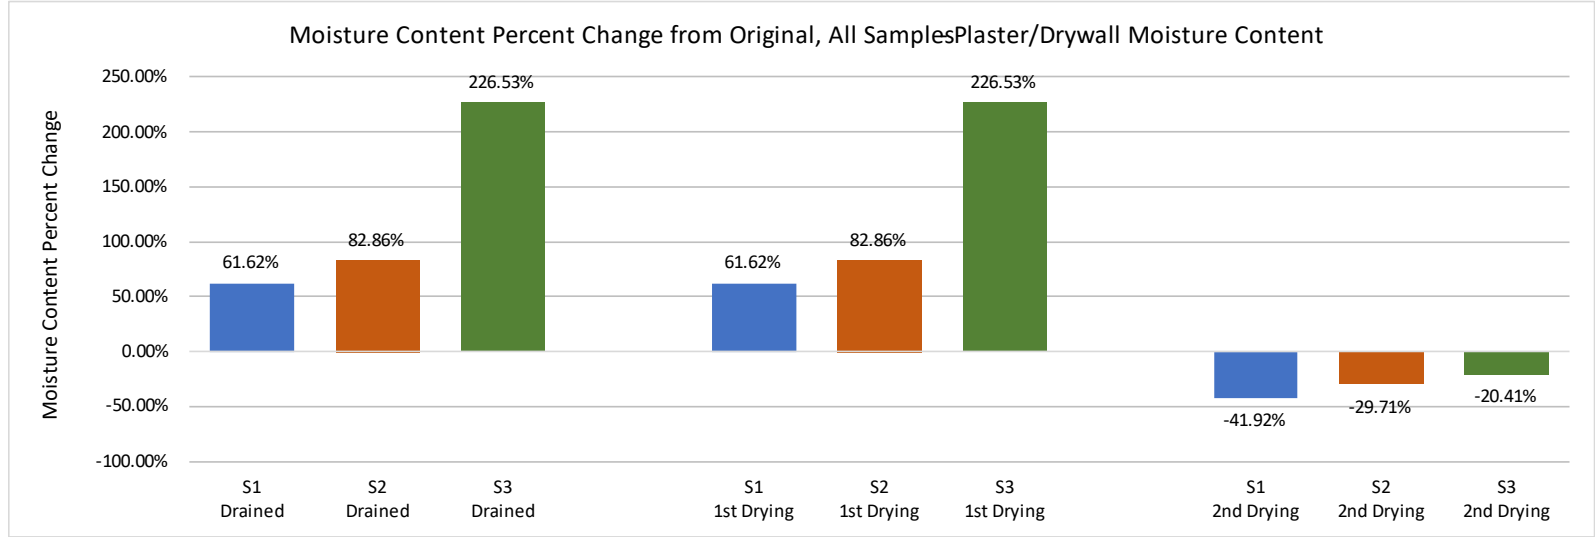
# TEST PROTOCOL 2.1 DATA

- Common wall assemblies in pre-1970 structures are highly survivable in flood scenarios.
- Plaster on wood or wire lath wall assembly are highly survivable in flood events

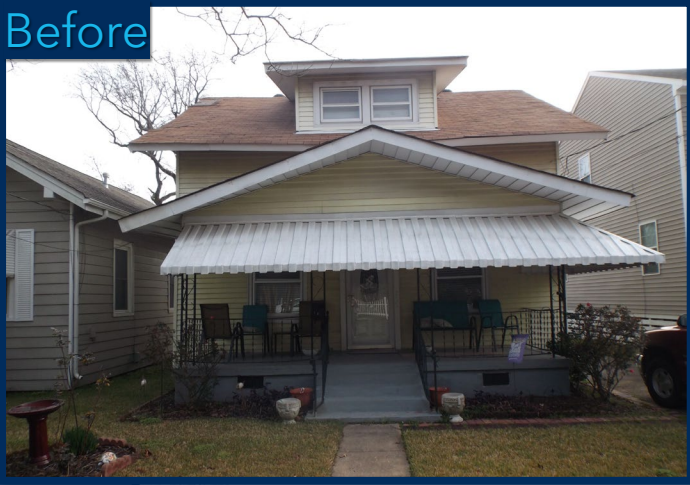
Before

## Background

c.1920s residence

- 1,082 SF
- 1.5 Stories

Chesterfield Heights Historic District

Family purchased 1964; first flood incident 2009

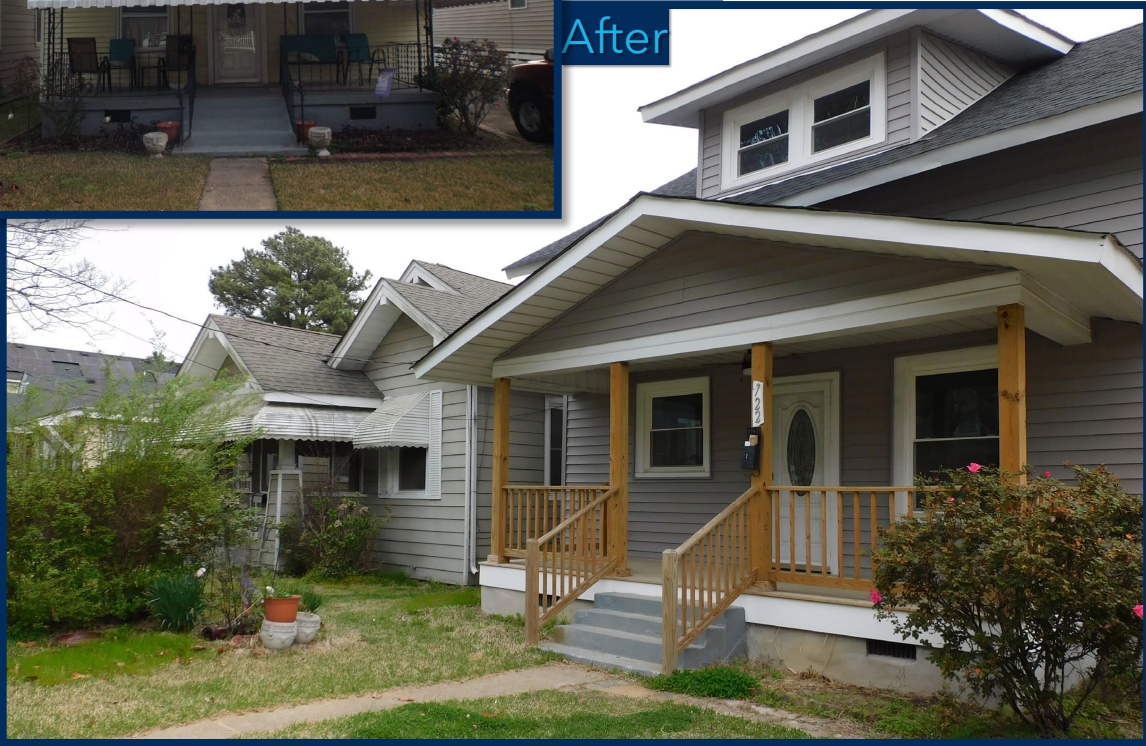
After

Project completed April 2023

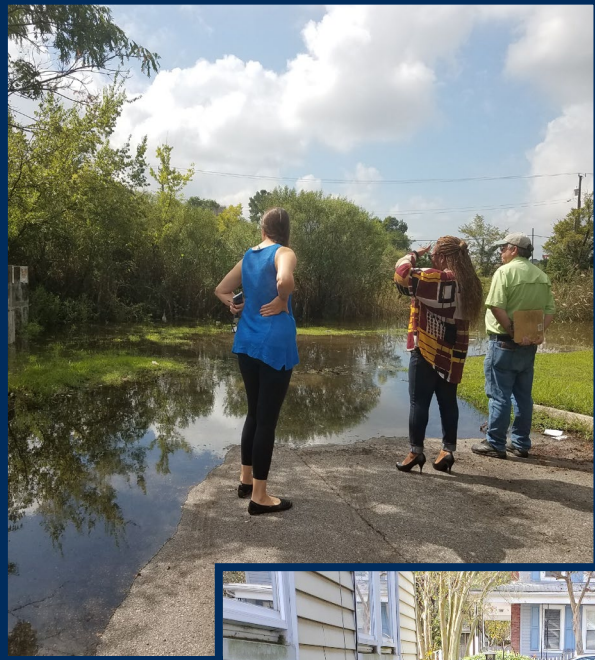
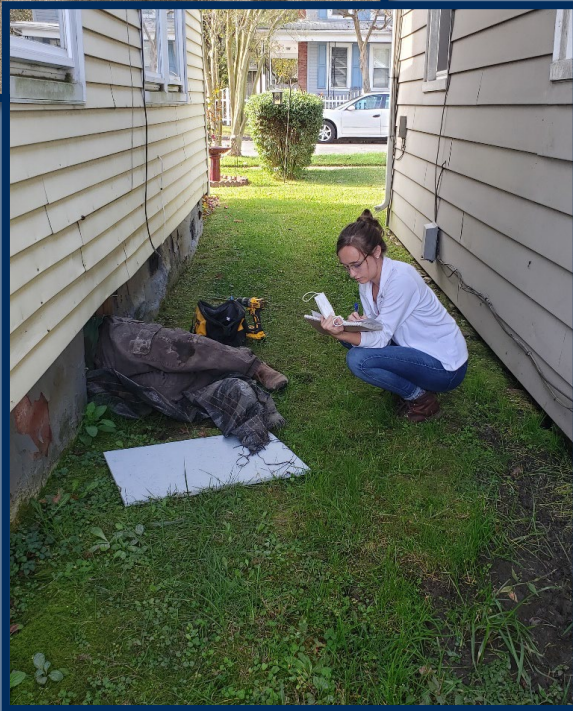
# OUR WORK: 722 FILER STREET

## Project Scope

- Owner to “age in place” with ADA mobility and care considerations for parent
- Involved Flood Mitigation and Retrofit
- Use of Moisture monitoring and Building Assessment
- Received a Special Flood Hazard Area Exception Approval from Norfolk's Floodplain Ordinance

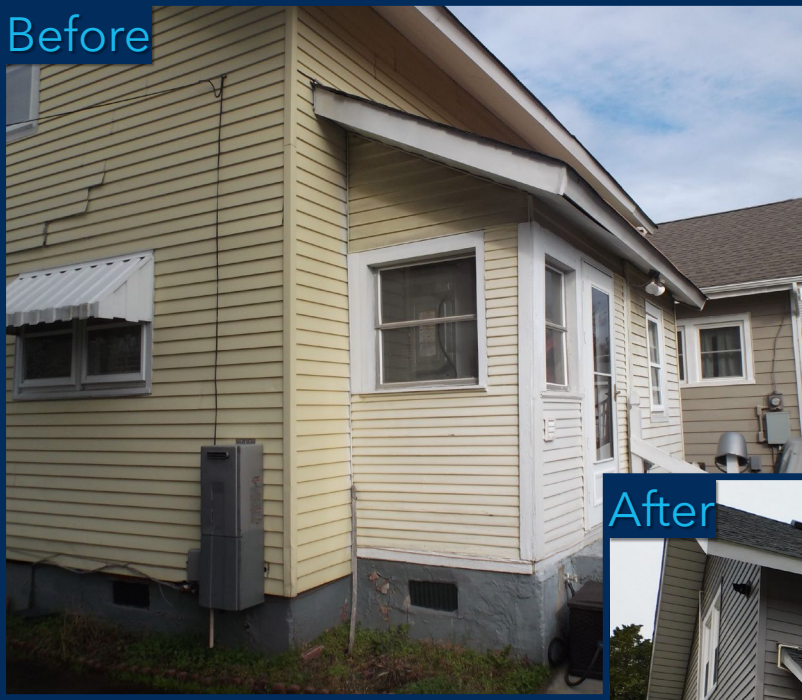
Before

- Regrade site
- Reinstate pier foundation and flooring system
- Install properly functioning gutters and downspouts
- Apply mold and rot resistant materials up to the DFE

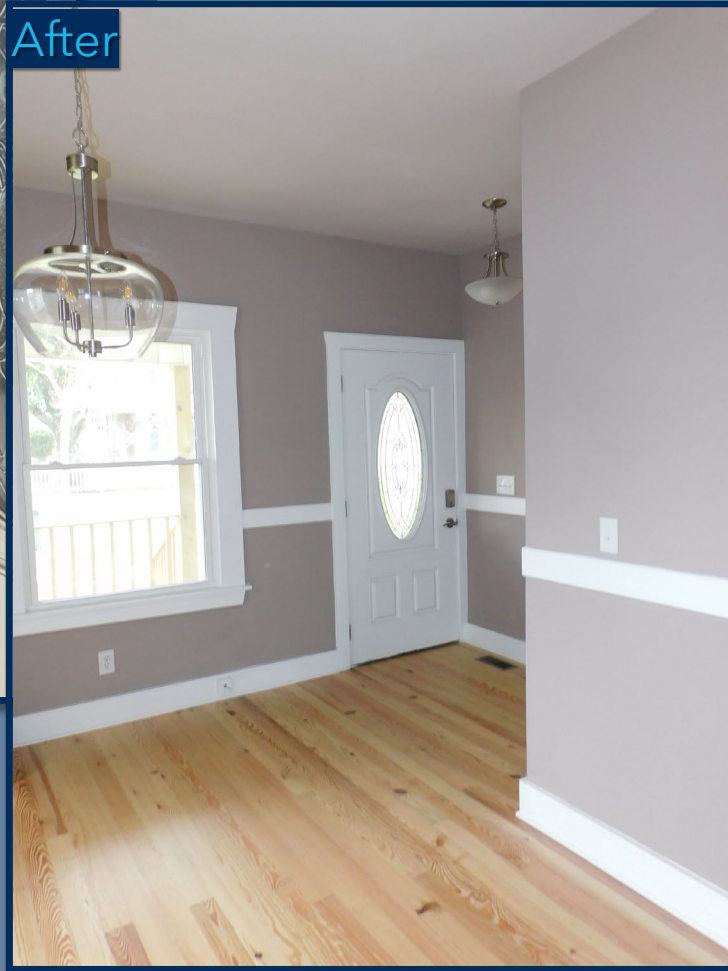
After

- Reconfigure floorplan
- Use of rot resistant materials
  - Fibrex board drywall below Design Flood Elevation with a 3" gap Above Finished Floor
  - Rot resistant framing and trim
- Historic/heart pine replacement flooring
- Electrical run in weathertight conduit polystyrene insulation
- Capillary break at the chair rail
- Slot at top for ventilation behind crown (in addition to base)
